Improvement through Innovation

Case Study: Improved Wear Liner Life

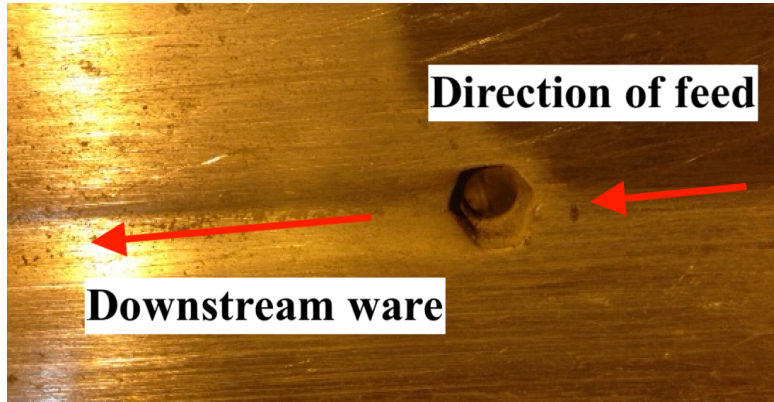
Wear is initiated at the bolt Hole location

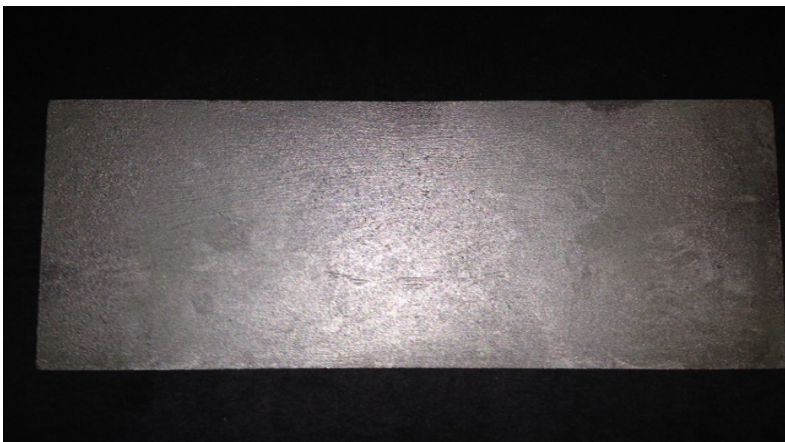
The operating surface Of the Wear Liner is clear of openings.

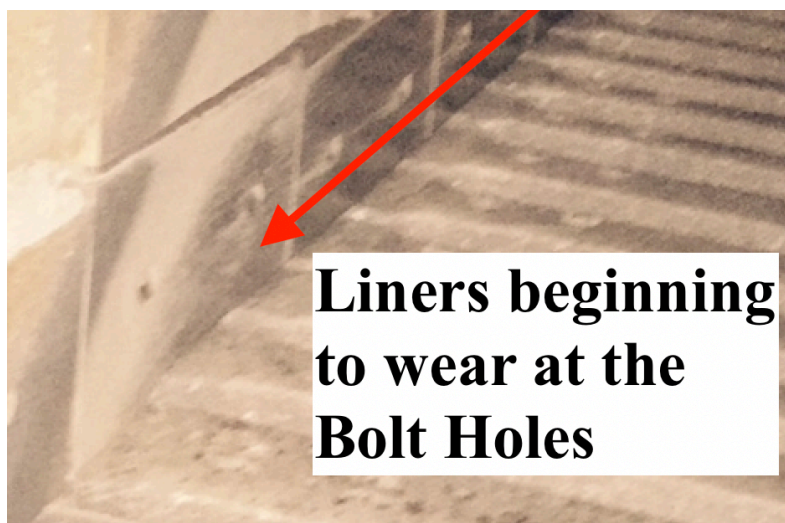
Side by Side test show Wear beginning at the On one side of the unit while the liners with Bolt holes show the Beginning of wear while The opposite side shows Very limited wear
