Improvement through Innovation

Case Study: Improved Wear Liner Life

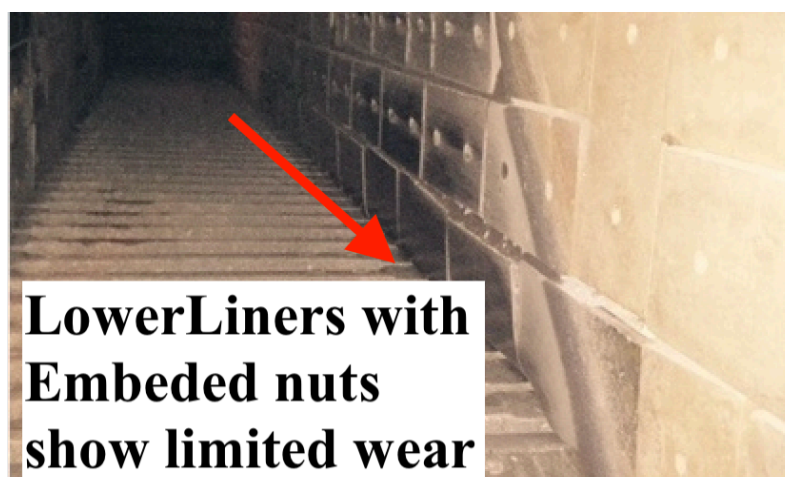
Side by Side test show Wear beginning at the On one side of the unit while the liners with Bolt holes show the Beginning of wear while The opposite side shows Very limited wear
